# MARYLAND HISTORICAL TRUST MAGI# 0422915712

## INVENTORY FORM FOR STATE HISTORIC SITES SURVEY

B-2291 American National Building and Loan Building (Park Bank Building; Offices of Con. Gas Electric Light & Power Co.; Liberty Building) 100 W. Lexington Street

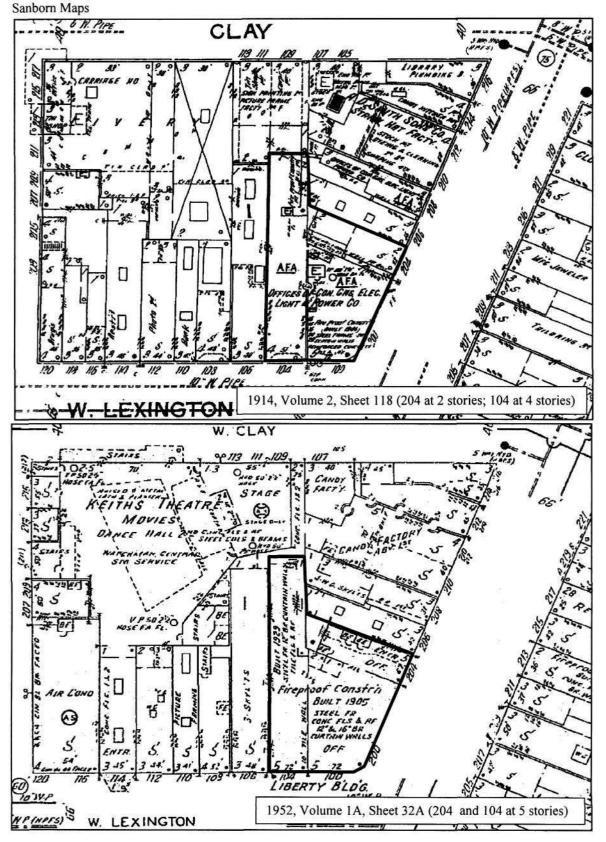
This commercial building is five stories high and eleven bays wide (the last two bays on the north end of the building are probably additions). The first story is polished granite; the next three stories are running bond-laid masonry; the fifth story is stone.

The heavily framed, flat arch entrance on the rounded corner of the building contains two sheet glass doors; five other flat arch, level framed windows also contain sheet glass. Just below the second story windows is a stone belt course underscored by a band of rondelles.
